5.0 RISKS AND HAZARDS OF DAM FAILURE

5.1 RISKS OF DAM FAILURE

5.2 TYPES AND CAUSES OF DAM FAILURE

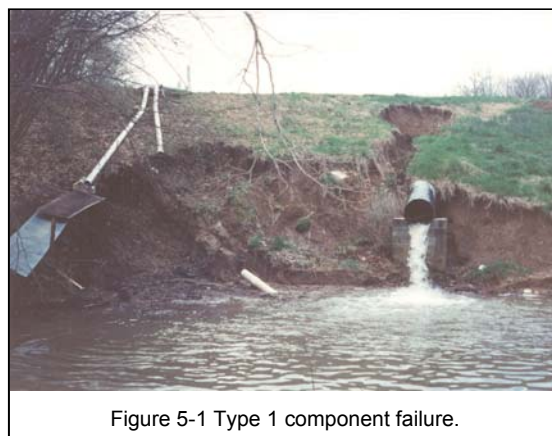
Figure 5-1 Type 1 component failure.

Type 1 failures include localized seepage and structural failures of dam components that do not breach the dam into the reservoir. Type 1 failures are generally local failures of a dam feature, such as an embankment slide that does not breach the crest, a spillway structural failure, a piping condition in its early stage of formation, a trash rack failure, or settlement on an earth dam embankment that does not extend to the water level. Type 1 failures are critical, require immediate attention, and may lead to a Type 2 failure. Type 1 failures may also require emergency response, reservoir drawdown, or remedial correction.

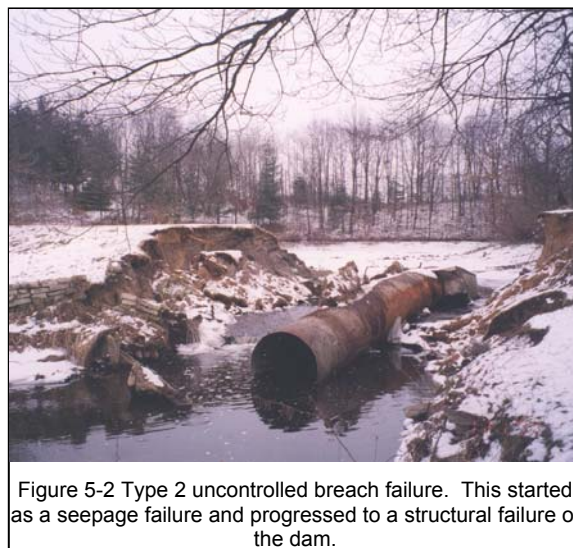
Figure 5-2 Type 2 uncontrolled breach failure. This started as a seepage failure and progressed to a structural failure of the dam.

Type 2 failures are failures that do result in a significant release of the reservoir and may eventually result in a dam breach with total release of the reservoir. There are three general categories of Type 2 failures: (1) hydraulic failures, (2) seepage failures, and (3) structural failures. Type 2 failures often result from Type 1 failures that were improperly corrected or were ignored.
